# STABILITY ASSESSMENT OF A HURRICANE MITCH-INDUCED LANDSLIDE DAM ON THE RÍO LA LIMA, SIERRA DE LAS MINAS, EASTERN GUATEMALA

Robert L. Schuster<sup>1</sup>, Robert C. Bucknam<sup>1</sup>, and Manuel Antonio Mota<sup>2</sup>

Open-File Report 01-120 (*English and Spanish*)

2001

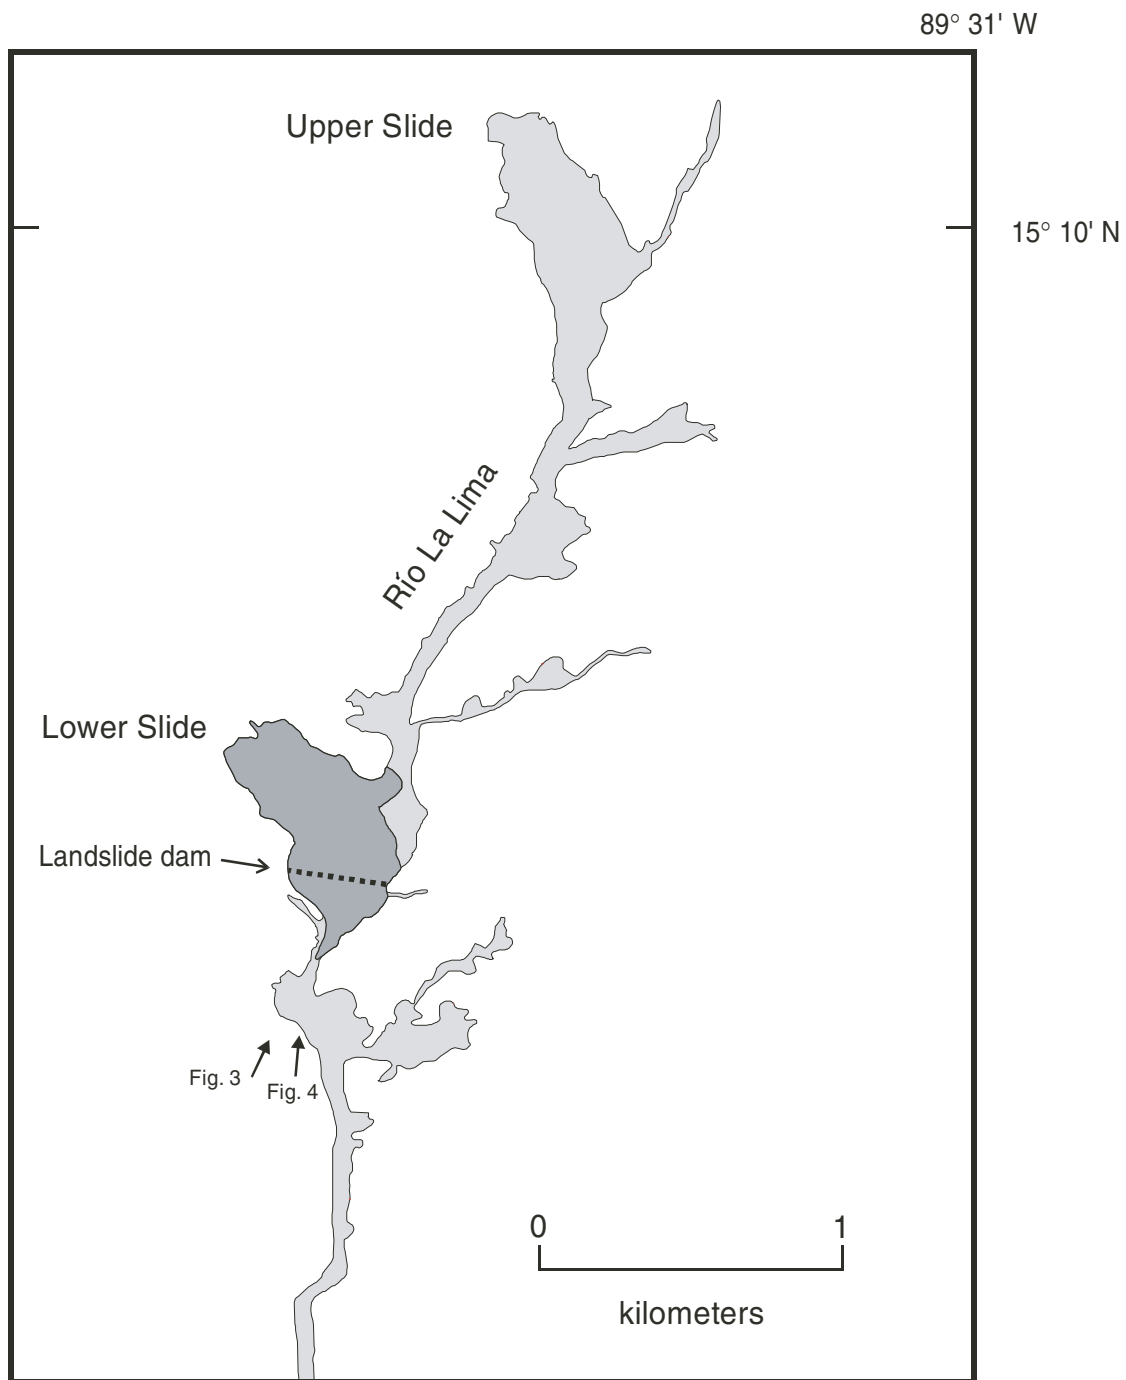
Fig. 2. Map showing areas (shaded) affected by landslides, debris flows, and flooding in the upper Río La Lima drainage. Dark shading shows the landslide complex that produced the landslide dam. Arrows show the approximate photo points and directions of view of Figs. 3 and 4.

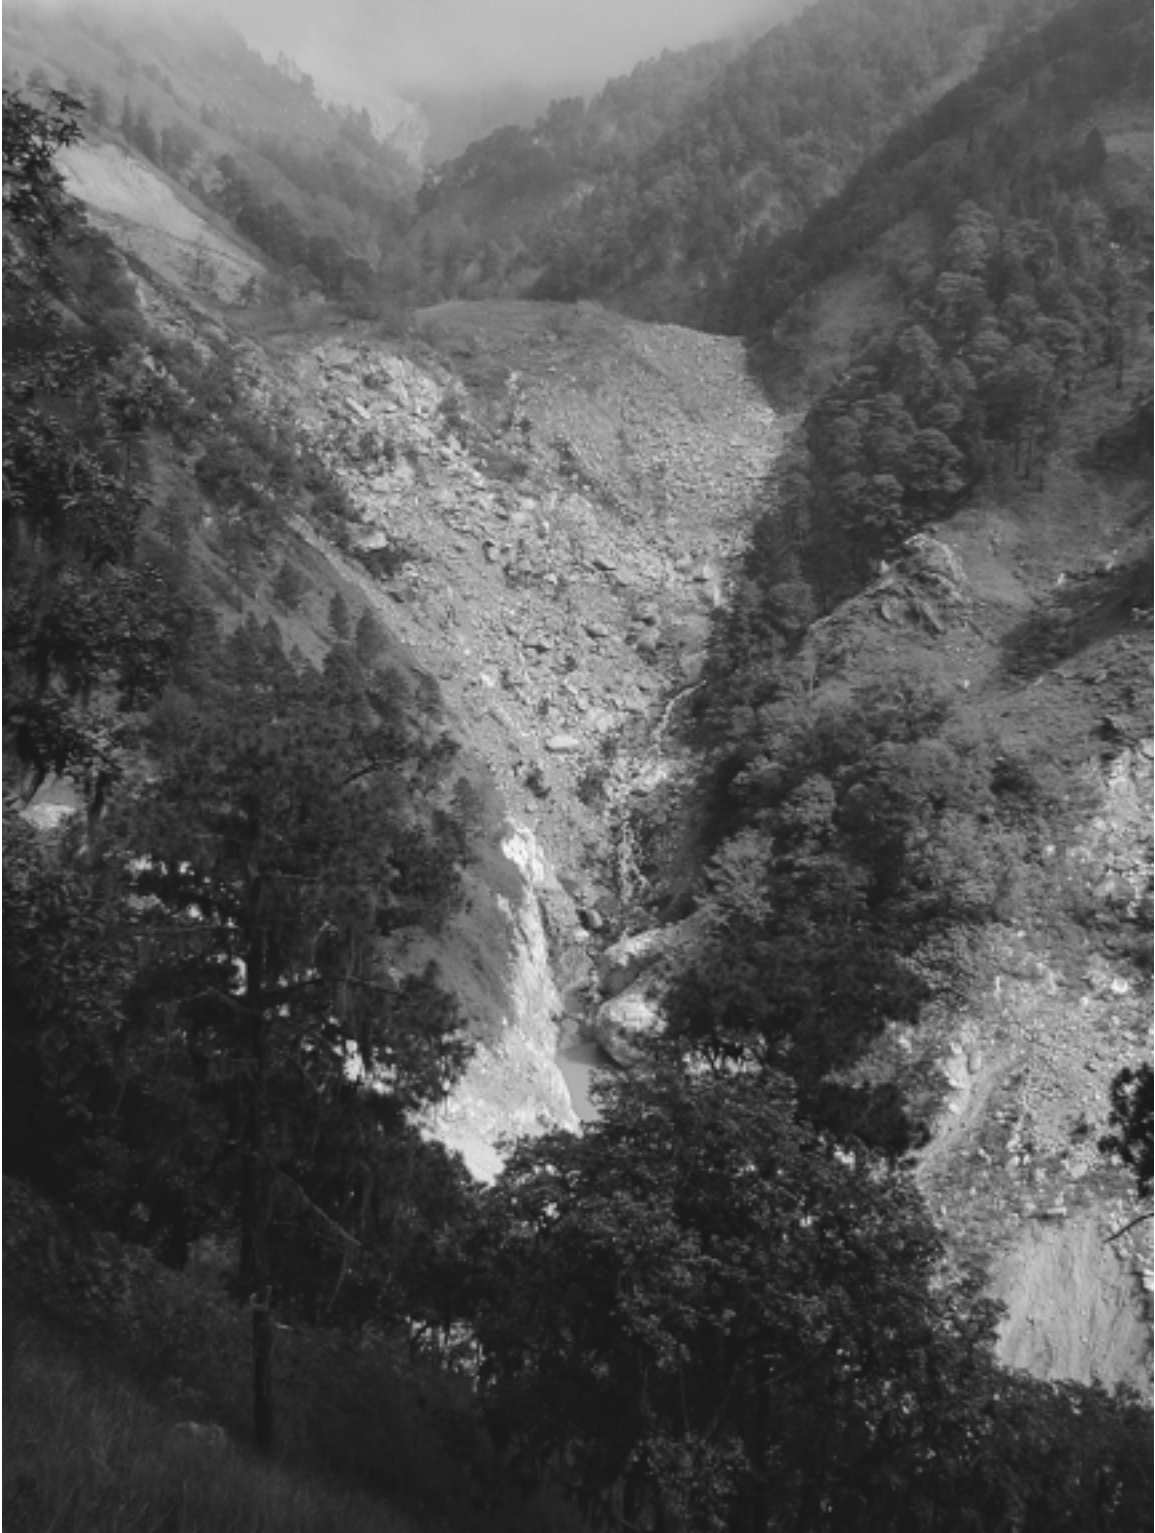
The landslide dam formed by the lower rock slide has a crest height of about 50 m above the former stream level, an estimated volume of 500,000 m<sup>3</sup>, and a downstream face slope of about 30°. An estimated 200,000 m<sup>3</sup> of additional sediment and water has been impounded by this barrier. The geologic materials comprising the slide and the natural dam were derived from the granite gneiss and schist that forms the western wall of canyon. These materials range in particle size from clays to boulders. The surface of the slide is irregular, is broken by many tension and shear cracks, and in September 2000 was covered by a thick growth of grass as much as 2 m high. Crossing the slide on foot was difficult because of the cracks, the very thick grass, and the slippery and irregular mixture of clay and rocks that make up the surface.

At the time of our visit, there was no flow of water over the crest of the dam. Instead, the Río La Lima flowed through continuous voids in the dam, exiting the dam about half way down its face as a large spring at the contact between the dam and the valley-wall left abutment. Although we were did not reach the point of discharge through the dam, it appeared from a distance that there was no evidence of active internal erosion (i.e., the exiting water appeared to be clear).

**Figure 3.** Landslide dam on the Río La Lima, looking upstream (north) from a point 4 km north of Jones; photograph taken 25 January 2000. The landslide originated on the steep slope in the upper left corner of the photograph (see figure 4). The point of discharge of the river from the debris that forms the dam is at the point where the water is first visible at the middle right part of the photograph.

However, we do recommend that the condition of the dam, its impoundment, and the outlet of the river through the dam be observed on a regular basis. This can be done by means of binoculars from the trail on the west side of the canyon at a location about one kilometer downstream from the dam and at a site where the trail intersects the landslide above the dam. If additional landslides occur in the vicinity of the landslide dam or elsewhere in the Río La Lima drainage above the landslide dam the stability of the dam should be reevaluated.

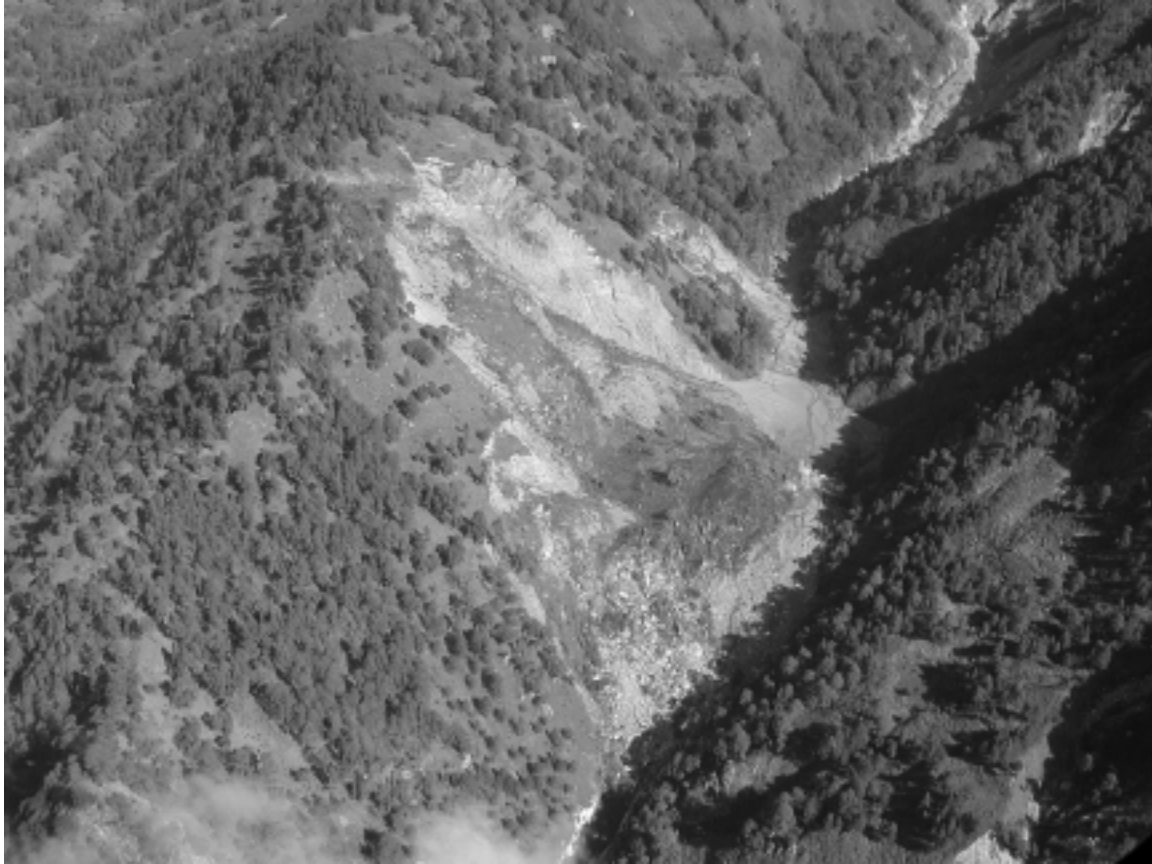
Shortly after the dam formed, the retention basin behind the dam partially filled by sediment eroded from the debris flow deposits that originated from the upstream slide. By the time of our visit, this basin had been almost filled by deposition of sediment from both slides. The only surface indications of impoundment of water by the dam were shallow ponds immediately behind the dam. Thus, the landslide dam functions much like a mine-tailings dam, retaining a mixture of about 200,000 m<sup>3</sup> of water and sediment.

**Figure 4.** Oblique aerial view to north of the landslide that produced the dam on the Río La Lima, photograph by Jeffrey Coe taken 12 January 2001. Smooth even-toned surface crossed by Río La Lima at the toe of the landslide is the sediment fill behind the landslide dam.
